Manhole Inspection Summary

Manhole # S23KK_011MH

Location Address: **2500 PENNSYLVANIA AVE**

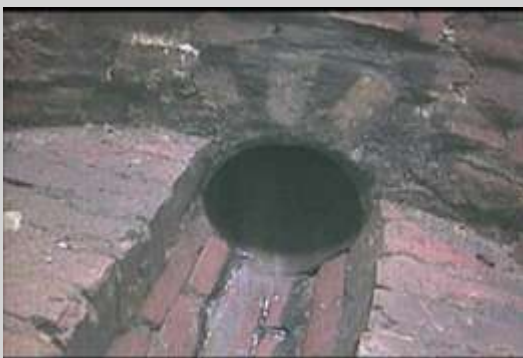
8 in. Circular Gravity Sewer Pipe In @ 6 O'Clock

Pipe Material: **Clay** ☐ Pipe Lined

Invert Depth: **8.34** (ft.) Flow Characteristics: **Slow**

Infiltration: **None** Pipe Seal Cond: **Unknown**

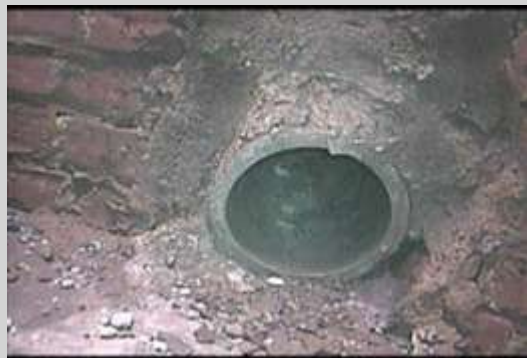
6 in. Circular Gravity Sewer

Pipe Material: **Clay**

Infiltration: **None**
